# Arizona State University Student Health Services

## Project Overview

The 34,000-square-foot Arizona State University Health Services Building (ASU HSB) is an adaptive reuse project that transformed the existing sterile and inefficient health clinic into a clearly organized, efficient, and welcoming facility. The design imbues the new facility with a sense of health and wellness that leverages Tempe's natural environment and contributes to a more cohesive pedestrian-oriented campus. The renovated facility, the new wing, and the entrance pavilion energize the surrounding campus by engaging the historic Palm Walk—the campus's main pedestrian spine.

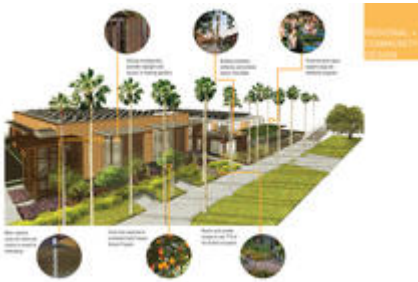
*Regional + Community  
Design - Photo Credit:  
Lake|Flato Architects*

The project engages and activates the historic Palm Walk, the campus's pedestrian main street, resulting in a more vibrant and cohesive campus fabric. Whereas the disjointed existing building provided little order for the Palm Walk, the transformed facility's main entry pavilion directly engages the pedestrian core, welcoming students under shady porches and a vine-planted trellis.

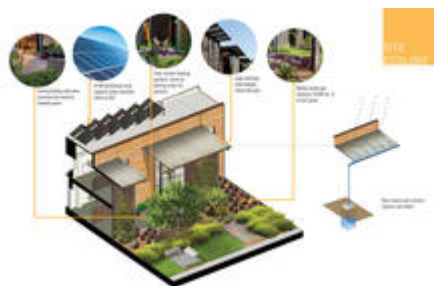
*Site Ecology Strategies  
Diagram - Photo Credit:  
Lake|Flato Architects*

The built facility represents a significant departure from the university's original approach to the building's phasing and expansion. At the project's inception, the university proposed maintaining the entire existing facility and adding a new two-story, 9,000-square-foot addition to the north end of the site on existing open green space. Through a thorough programming and cost analysis process, the design team recommended renovating the 1950s 14,500-square-foot two-story wing, deconstructing the oldest and least efficient single-story part of the facility, and constructing a new 20,000-square-foot two-story addition in its place. The solution significantly increased the facility's efficiency, reduced program by 12% and the facility's footprint by 20% while preserving 5,000 square feet of open green space. Additionally, the revised concept enabled the renovated facility's main entrance to be located on the historic Palm Walk, the campus's main pedestrian spine, resulting in a more accessible facility and vibrant pedestrian campus. The revised concept also facilitated the removal of approximately 10,000 square feet of turf grass, replaced by native landscaping irrigated by rainwater harvested from the facility's roofs and stored in sub-grade cisterns.

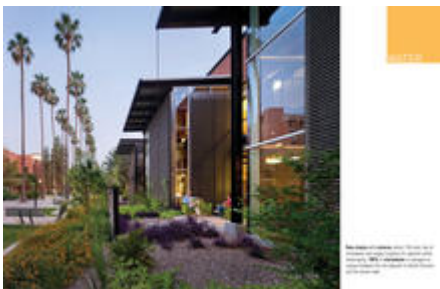
*Rain chains with cisterns collect 138 cubic feet of stormwater and supply irrigation for adjacent native landscaping. All of stormwater is managed on campus between the site adjacent to Health Services and the alumni lawn. - Photo Credit: Bill Timmerman*

Finally, the project supports ASU's campus-wide goal of managing all stormwater on campus. The existing alumni lawn was leveraged to aid in stormwater management instead of adding new infrastructure to the project. All stormwater is managed on site or on the alumni lawn adjacent to the Health Services Building. Rain chains attached to subsurface cisterns account for 138 cubic feet of rainwater harvested from the lower roofs, which is used to irrigate the project's native landscaping. The cisterns utilize pieces of recycled concrete slab from the existing building.

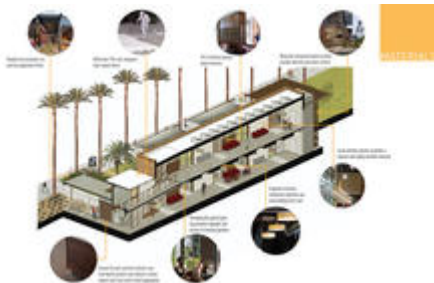
*Materials & Construction  
diagram - Photo Credit:  
Lake|Flato Architects and  
orcutt|wilson*

The first priority was to do more with less. Recycling the original Health Services Building allowed the team to reuse 76% of the existing structure. The team also eliminated extraneous finishes, exposing systems that celebrate the building while minimizing maintenance.

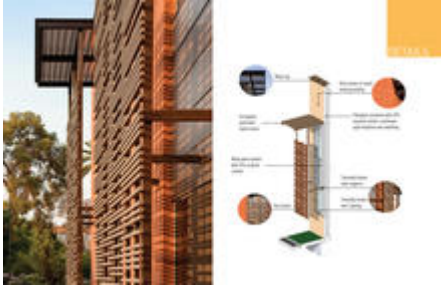
*Building envelope detail  
showing passive systems  
selection - Photo Credit: Bill  
Timmerman*

On the exterior, the design uses regional materials appropriate for the harsh Tempe environment and native to the campus: Brick, natural metal panel, exposed weathered steel, and stained concrete. Overhangs and screens of recycled composite wood are incorporated to protect glazing and preserve the building envelope. The screens act as armatures for vines and create a “living” building, becoming lusher over time while mitigating the thermal loads.

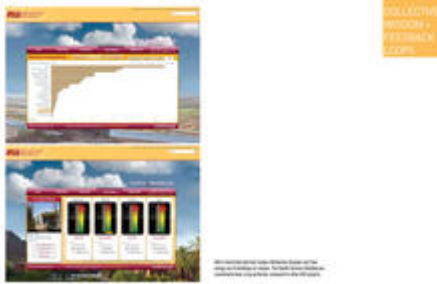
*ASU's interactive web tool  
Campus Metabolism displays  
real-time energy use of  
buildings on campus. The  
Student Health Services  
Building has consistently been  
a top performer compared to  
other projects on campus. -  
Photo Credit: cm.asu.edu*

ASU utilizes an interactive website called Campus Metabolism ([cm.asu.edu](http://cm.asu.edu)) that enables the public to view the current resource use of numerous buildings on campus, including the Health Services Building. ASU is currently installing sensors on campus buildings and tracking energy, including chilled water, electricity, and hot water/steam. In the near future, Campus Metabolism plans to display water and waste, as well as other important resource information. The Health Services Building's energy performance can be viewed in real-time and compared to other projects on campus on this website. Per square foot, the Health Services Building is consistently one of the top performers on campus.

Historical data for performance can also be viewed on this website, which proved to be a valuable diagnostic tool for this project. The team noticed a spike in heating energy last July and was able to troubleshoot and find a steam leak in the building, an issue that may not have been identified without this tool.

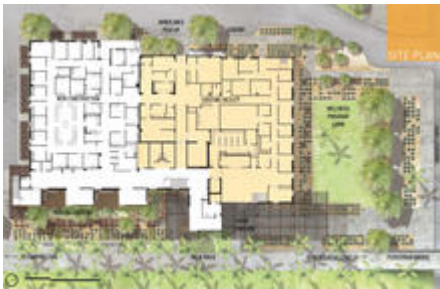
*ASU Student Health Services  
Building Site Plan - Photo  
Credit: Lake|Flato Architects*

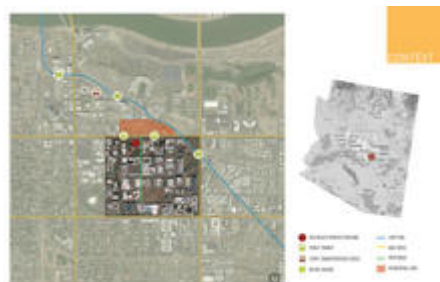
*Context plan showing how the  
project connects to its place,  
region, and neighborhood -  
Photo Credit: Lake|Flato  
Architects*

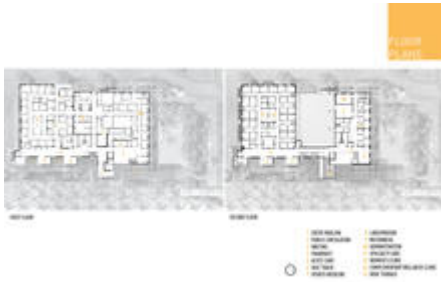
Floor plans - Photo Credit:  
Lake|Flato Architects
