Mercy Corps

Project Overview

Their new headquarters is comprised of the restoration of a 42,000 sf neglected historical landmark in a challenging urban district and an addition of similar size. An egalitarian layout and environmental features actualize Mercy Corps' mission to foster sustainable economic development through collaboration and self-empowerment while also helping to revitalize the neighborhood.

THA Architecture

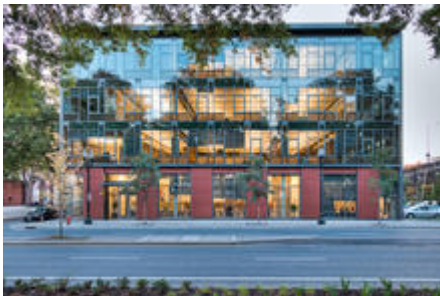
*Ample views and daylight
reach almost every occupant -
Photo Credit: Jeff Amram*

Ample views and daylight reach virtually every work space and increase the indoor environmental quality for the occupants. The furniture is pulled off the windows and uses low, translucent end panels for equitable access to daylight through the space. Efficient lighting design and sensors work with the natural light to reduce overall lighting loads. Individual task lighting also reduces the need for ambient lighting.

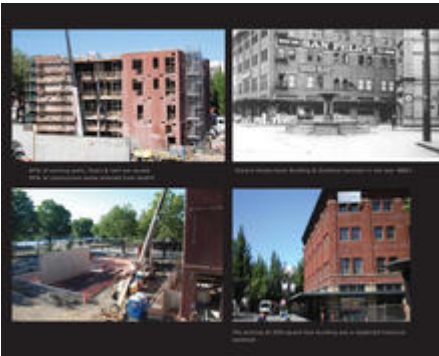
87% of the existing historic Packer-Scott building was re-used. - Photo Credit: THA Architecture

87% of the existing historic Packer-Scott building was re-used. Wood from the existing building was used in finish elements in the new addition in the main stair treads and the reception desk as well as at the coffee bars. During construction, 95% of the waste was diverted from the landfill through recycling or reuse.

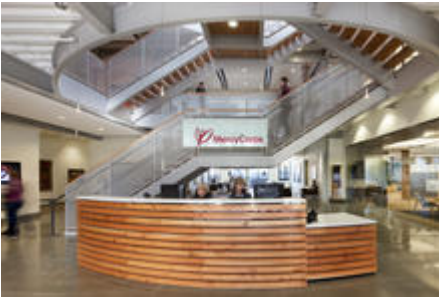
Wood from the existing building was used in finish elements at the reception desk and on the main stair - Photo Credit: Lara Swimmer

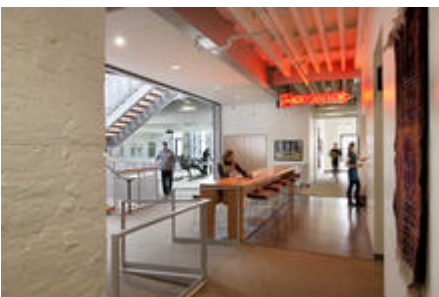
Structural systems were left exposed and minimal finishes applied to save materials - Photo Credit: Lara Swimmer

Structural systems were left exposed and minimal finishes applied to save materials. The raw background is then offset by colorful artwork and artifacts collected from around the world, which inspired the building design, resulting in a simple yet rich environment.
