## Mercy Corps

### Project Overview

Their new headquarters is comprised of the restoration of a 42,000 sf neglected historical landmark in a challenging urban district and an addition of similar size. An egalitarian layout and environmental features actualize Mercy Corps' mission to foster sustainable economic development through collaboration and self-empowerment while also helping to revitalize the neighborhood.

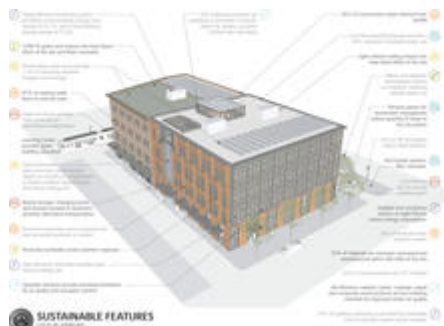
*Mercy Corps Sustainable Features - Photo Credit: THA Architecture*

For the new addition, an exterior terra-cotta rainscreen system (its first use in Oregon) has a textile-like pattern, referencing cultural artifacts collected by Mercy Corps and complementing the scale and proportion of the adjacent facades. Its transparency and materiality provide a symbolic link between the organization and the community.

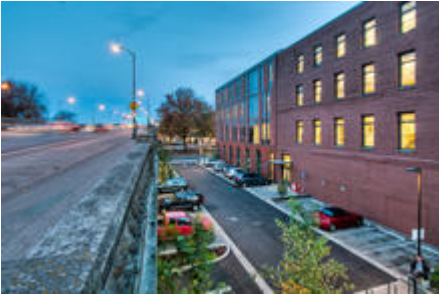
*The small parking lot to the north is paved with pervious pavement to encourage direct ground infiltration during rainfall - Photo Credit: Jeff Amram*

The building redeveloped a major brownfield and infill site in the city, densifying and reinforcing the urban fabric while protecting adjacent environments, which include a significant urban park and weekend public market. Full cut off downlights for site lighting reduce light pollution, and the small parking lot to the north is paved with pervious pavement to encourage direct ground infiltration during rainfall.

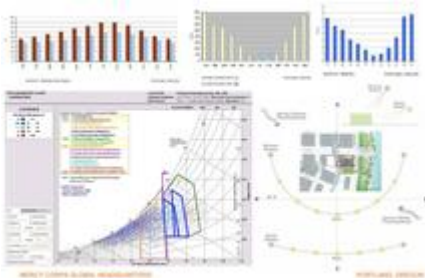
*Bioclimatic information -  
Photo Credit: THA Architecture*

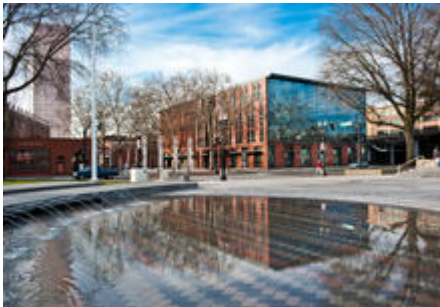
*The building is oriented east-  
west - Photo Credit: Jeff  
Amram*

The building is oriented east-west, responding to the existing urban grid and allowing for smaller elevations on the east and west, which are difficult to shade. The building took advantage of the existing small openings on the west and southwest sides of the historic building to reduce exposure to the hot afternoon sun.

The long southern elevation is half existing historic punched windows and half new skin using similar glazing percentages. Large trees south of the building provide shade to the building during the warm summer months while allowing beneficial heat gain during the winters. The glazed east elevation permits natural light and beautiful views to the waterfront, while different window opacities limit solar gain.

Operable windows on all four sides allow the interior to benefit from natural light to virtually all work spaces and for the building to take advantage of the temperate climate and breezes channeled along the river. Sunshelves used above the storefront windows provide protection from summer sun and for pedestrians in this rainy climate. The main entry is marked with a glass wall in the middle of the south façade and is protected by glass louvers that automatically adjust based on outdoor temperature, providing shade when needed and maximizing energy performance.

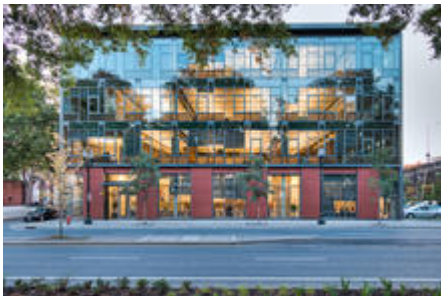
*Ample views and daylight  
reach almost every occupant -  
Photo Credit: Jeff Amram*

Ample views and daylight reach virtually every work space and increase the indoor environmental quality for the occupants. The furniture is pulled off the windows and uses low, translucent end panels for equitable access to daylight through the space. Efficient lighting design and sensors work with the natural light to reduce overall lighting loads. Individual task lighting also reduces the need for ambient lighting.

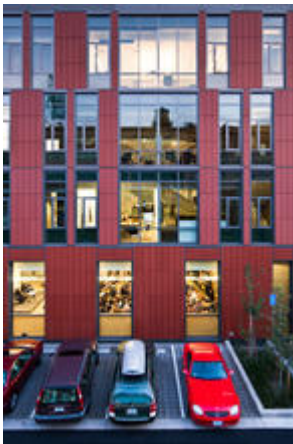
*On-site paving is pervious to encourage direct ground infiltration - Photo Credit: Jeff Amram*

Potable water use was reduced by 40% by installing water-saving plumbing fixtures, such as low-flow faucets and dual-flush toilets. Landscape plants are xeriscaped to eliminate the need for irrigation water, resulting in a more than 50% reduction of potable water consumption for irrigation. On-site paving is pervious to encourage direct ground infiltration during rainfall.

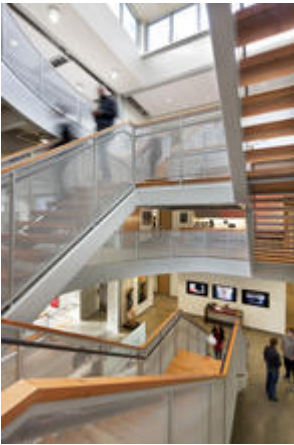
*A central core with a motorized roof monitor above aids in the stack ventilation - Photo Credit: Lara Swimmer*

The mechanical system was designed to be simple, decreasing operation and maintenance costs while operating efficiently and in conjunction with other strategies to reduce overall energy use. The grand staircase at the heart of the building acts as a ventilation stack, drawing air in and up through a monitor-controlled clerestory. Combined with operable windows, this strategy reduces any need to cool the building by drawing cool summer breezes from the north side to the south side of the building and stair stack. During the winter months, however, the north side of the building benefits from passive solar heat gain.

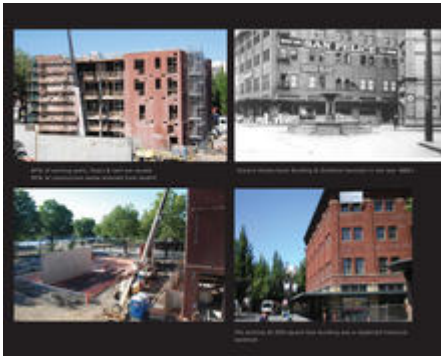
*87% of the existing historic Packer-Scott building was re-used. - Photo Credit: THA Architecture*

87% of the existing historic Packer-Scott building was re-used. Wood from the existing building was used in finish elements in the new addition in the main stair treads and the reception desk as well as at the coffee bars. During construction, 95% of the waste was diverted from the landfill through recycling or reuse.

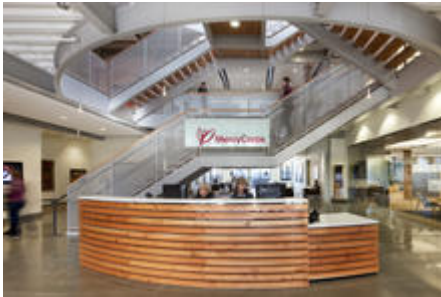
*Wood from the existing building was used in finish elements at the reception desk and on the main stair - Photo Credit: Lara Swimmer*

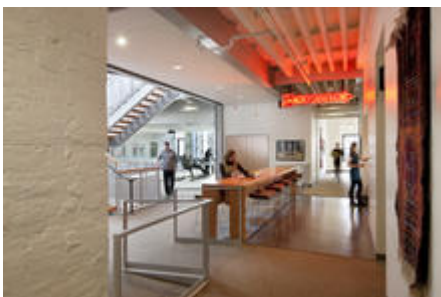
*Structural systems were left exposed and minimal finishes applied to save materials - Photo Credit: Lara Swimmer*

Structural systems were left exposed and minimal finishes applied to save materials. The raw background is then offset by colorful artwork and artifacts collected from around the world, which inspired the building design, resulting in a simple yet rich environment.

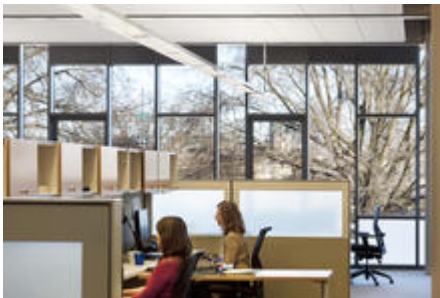
*The furniture used a new “benching” system comprised on a spine with movable tables and files - Photo Credit: Lara Swimmer*

On the interior, the large number of open office areas allows for flexibility for future changes. In addition, the furniture used a new “benching” system comprised of a spine with movable tables and files. This allows easy expansion and contraction of work stations or quick rearranging of teams for emergency response. Finally, the manufacturer, Herman Miller, has committed to sustainable practices in its factory and materials; they not only accept systems at the end of their life but also recycle most of the components.
